Service report for repair of coal mill separator rotor shaft dated 27.11.2021

ULTRASONIC EXAMINATION REPORT

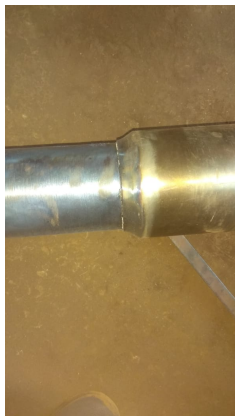
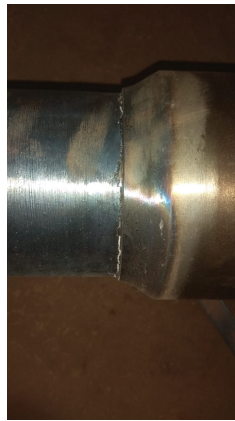
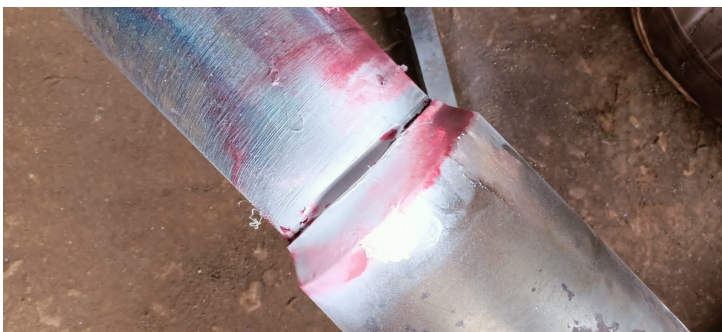
Picture of repair of shaft are as below:

The shaft was received by M/s A D technocrats on 28.10.2021 for repair of NDE side bearing size. After thorough check we submitted the offer for same. Initial UT results showed fusion error which were further justified when we took an undercut and shaft was preheated to start welding, a neck crack was visible which was when gauged and it was confirmed that earlier shaft was repaired using Bush sleeve method.

After submitting initial report of repair, we recommended to remove the old bush and built up entire area with welding to clear the final UT results and provide more strength to shaft bearing area for longer life.

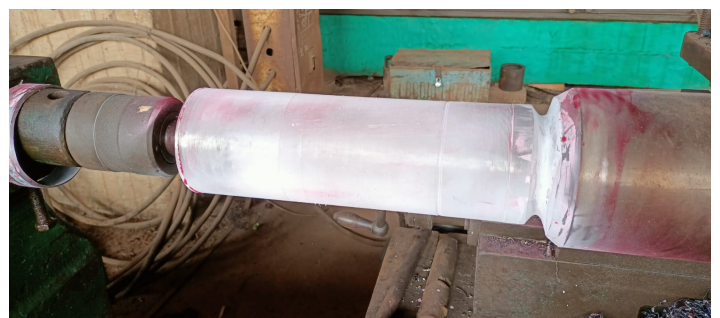
Images of shaft after precept and removal of old bush and after DP test it was verified that there is no further defect in shaft and it is ready for repair built up.

2. It was confirmed with further investigation after precept that shaft was repaired earlier suing bush sleeve method
3. After removing the old bush UT test and DP test were conducted to ensure that shaft is free from any kind of defect and ready to built up.
